Golf Hammock Owners' Association

Drainage Report

**Lost Ball Drive, Cormorant Point Drive, Dog Leg Drive, Waterwood Drive &
Cormorant Point Drive Intersection Areas**

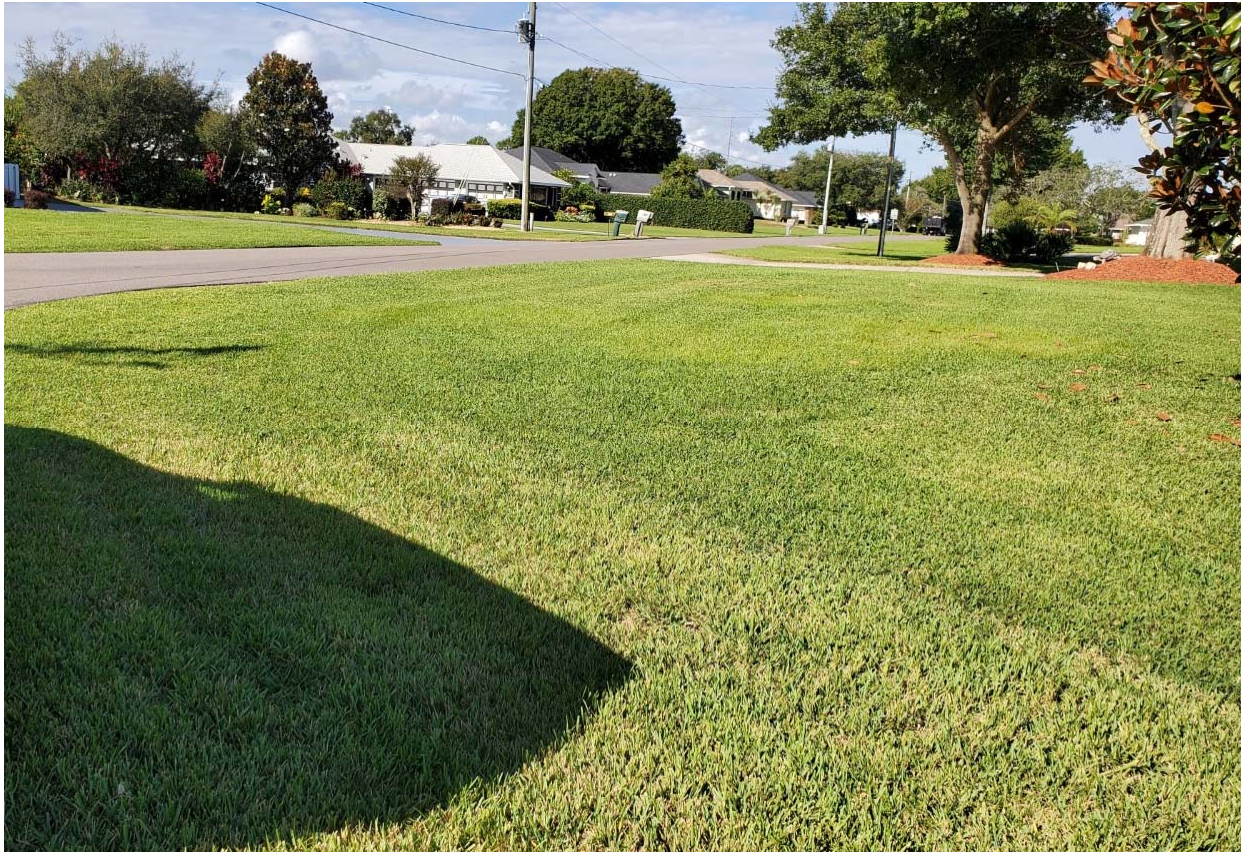
Some of the causes of the standing water can be associated with irregular grading of the area, rises and dips holding water. The roads and ditches do not have much slope in the areas of the water standing. It does not take much to cause the water to puddle or get blocked. The driveways are also higher than the ditch bottoms in most cases. This will create a driveway dam or ditch block. This should not be considered a bad thing. It will promote water to percolate back into the ground. In some cases, during a wet rain season, the water table can be elevated causing the water to appear to stay for extended periods of time. Lost Ball also has a number of intersections that do not have any culverts crossing under the road. The original plans intended the water to flow around the corners and to the west down Pitching Wedge and Dog Leg. The inspection during the site visit and looking at some older topo, show the ditches and road slope up for a short length before sloping back down to the west. This explains some of the backup of water on the westerly side of Lost Ball Dr.

Image of westerly side of the road near the Dog Leg Drive Intersection
The ditch is very shallow and the running slope is very little.

Solutions to the standing water in this area may involve additional ditch cleaning as well as the addition of some culvert crossings near the intersections along Lost Ball. The installation of sock pipe may also help to draw down the water in the ditches. This solution would need a good positive outfall location. In this case, the golf course ditch or pipe, if it exists, may need to be improved or cleaned out. Alternate options may include not doing anything. If the water in the ditch percolates or evaporates in 24 to 48 hours, it is normal behavior for this area of Highlands County. The water table can vary from 6+ feet to the surface within Golf Hammock, depending on the soil type (see soil map in the appendix). If the area is experiencing a very wet rainy season, the water table will likely be closer to the surface, which can cause the water in the ditches to stay longer before it percolates. If it is uncommon for the water to stay past 48 hours, it may be safe to postpone any major drainage improvements in the area. It is our recommendation at this time to observe the conveyance systems that take the water away from Lost Ball. This includes the pipe within the golf course and the pipe crossing Lost Ball to the south. It is also recommended to have the existing pipe located so it may be further inspected for condition and blockages and future maintenance. Flow issues can also be determined once this is done. The downstream system will need to be in good working order before any additional flow is tied into it from the upstream side of the drainage system.

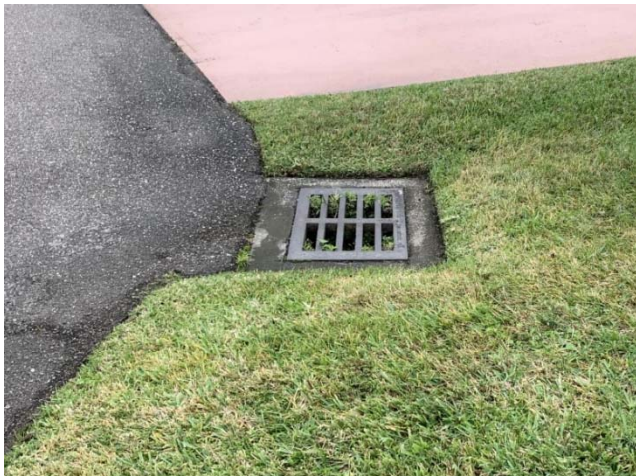
Cul-de-sac Inlet

The easterly side of the road near 9th Tee Ct. currently appears to have the ditch terminate at the pavement edge on 9th Tee. It then flows over the road to an inlet at the end of the cul-de-sac. Upon further investigation, the inlet only has a 4" or 6" out fall pipe. It heads to the east to the golf course and has no apparent outfall. The original drainage plans called for a ditch along the back of all of the homes along Lost Ball and the flow was to head to the south. No apparent ditch was present during the on-site investigation. Going through some older files turned up a possible plastic pipe that runs along this ditch area to the south. It was not possible to verify its location or condition due to the lack of any inlets or clean outs that were visible. The older files pointed to the two inlets that cross the southern most part of Lost Ball Dr. near Hammock Falls. These two inlets confirmed the size and location of the pipe. The older files show that it runs to Hammock Road and runs in the northerly right of way to the easterly side of the main Golf Hammock entrance.

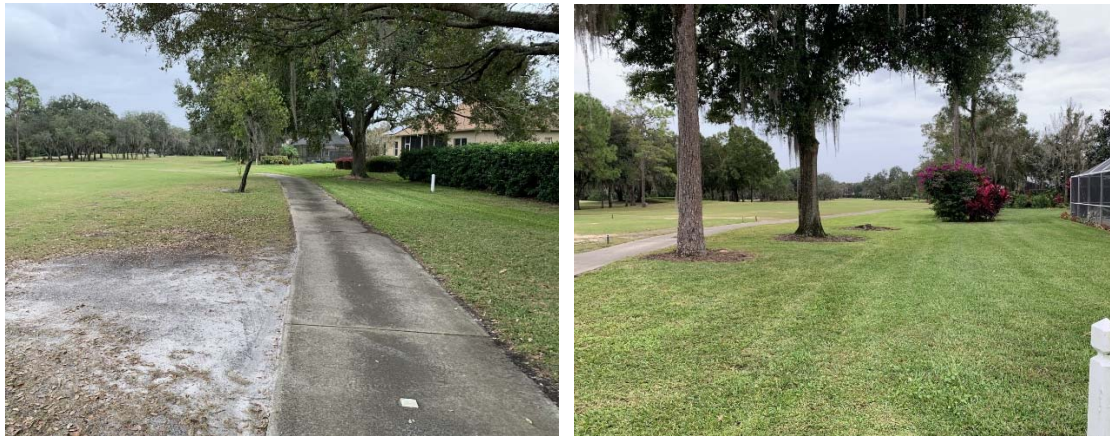
Views facing south in rear of Golf Course Lots

No apparent swales or evidence of drainage pipes were found during the on-site inspection.

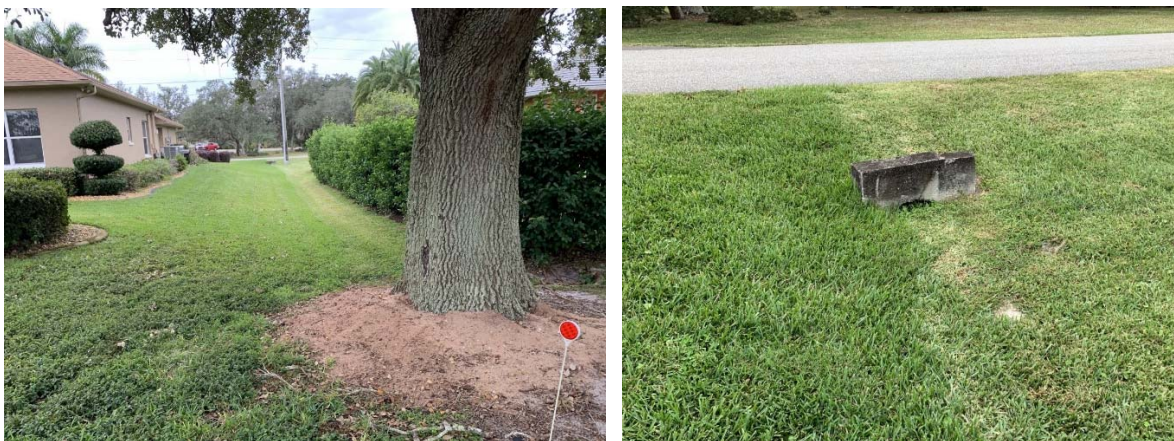
Culvert crossing and side lot ditch taking water towards the Golf Course

No apparent outfall or location for water to flow. Original plans show the flow arrows conveying the water to the east to the Golf Course. The lack of ditch in the golf course and large oak tree appears to be preventing any outfall path.

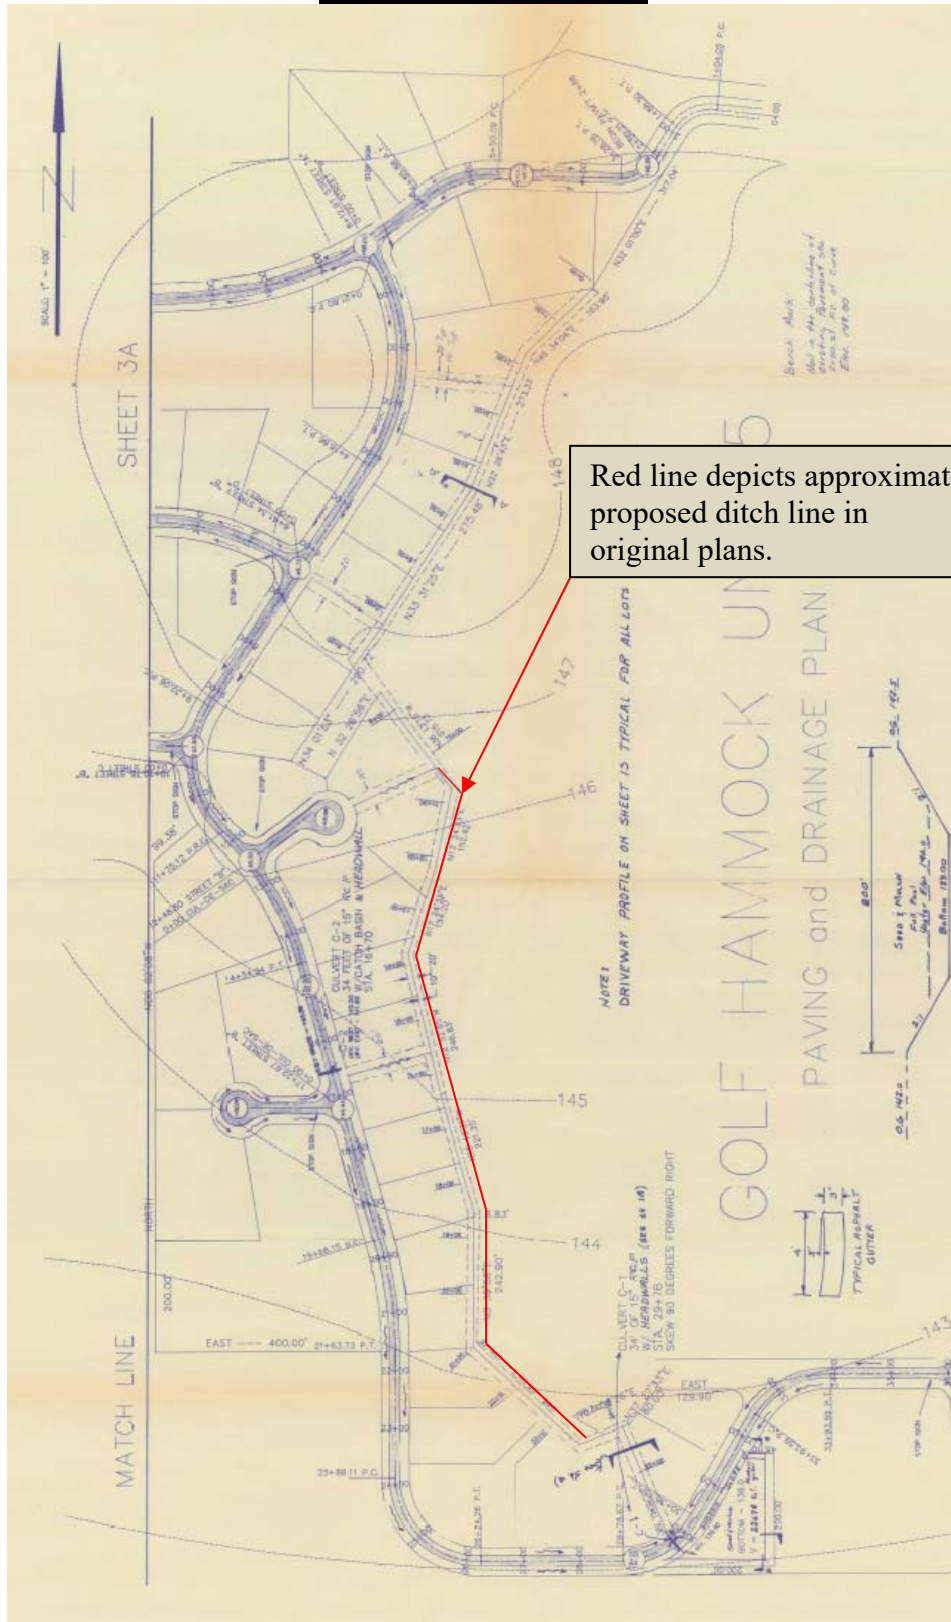
Lost Ball Original Plan:

Red line depicts approximate proposed ditch line in original plans.

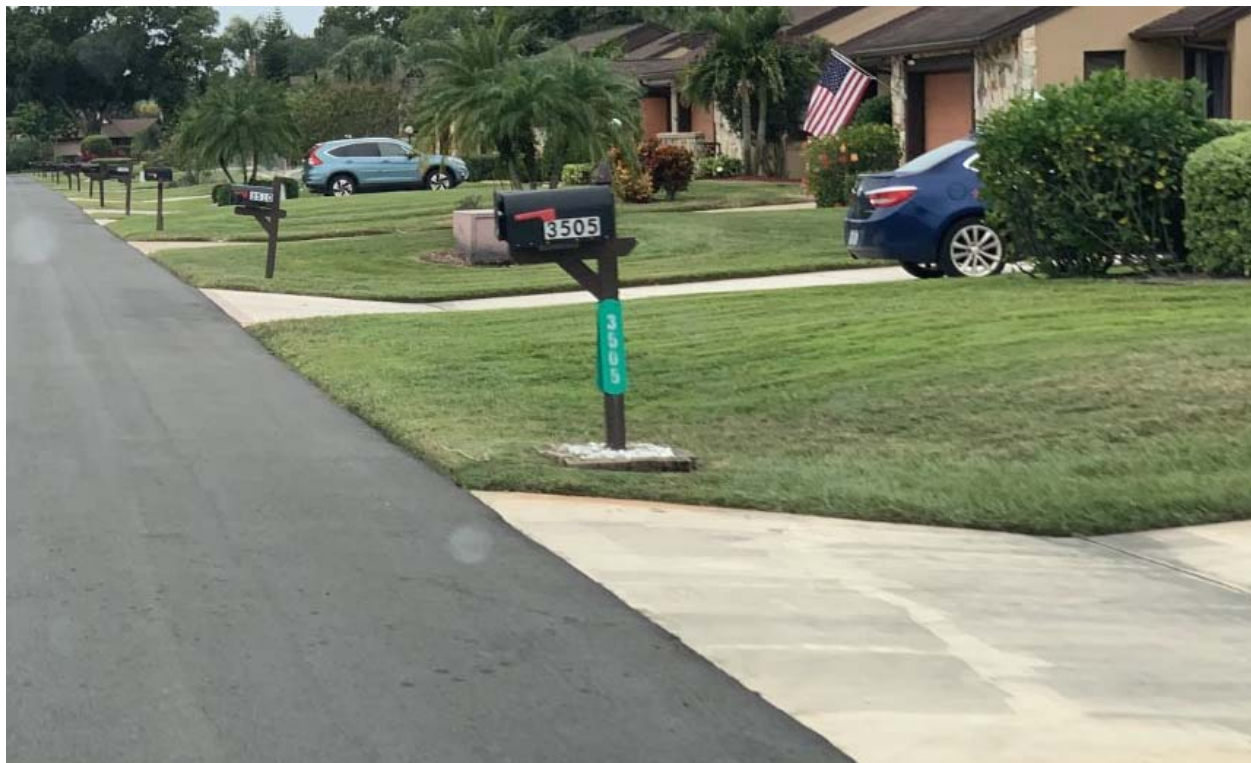
Yards Causing the issues:

The apparent cause of the water backup is what appears to be fill placed within the right of way ditches between 3502 and 3602.

Solutions for this area would require this location and the next three ditches between the next four driveways need to have the ditches reshaped. Once the ditch is reshaped the water should be able to flow west without backing up and going into the road. Alternates may include the installation of a culvert, but this may be cost prohibitive and may not allow for proper cover on the pipe.

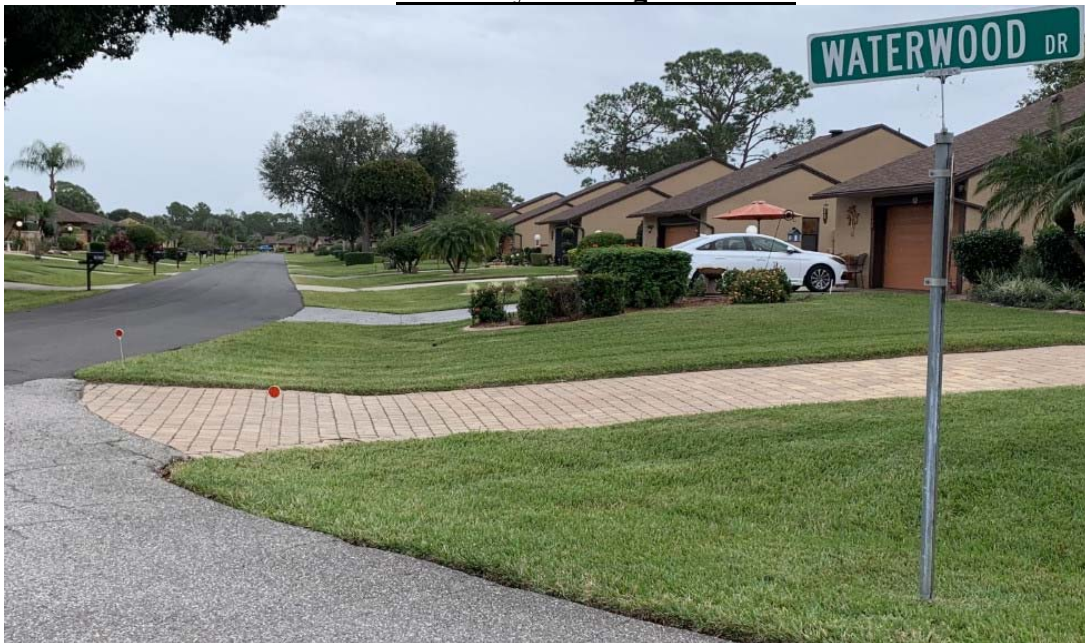
Driveway Causing the issues:

The problem reported for the intersection of Waterwood Dr. and Cormorant Point Dr. was water was standing and getting blocked by the driveway at 3813 Cormorant Point Dr. During the initial inspection, it appeared that the driveway was the culprit in not allowing any flow from the easterly side to cross to the intersection and down Waterwood Dr. After a closer look, it appeared a four-inch pipe was constructed under the paver driveway. This is normally not recommended due to its small size and its ability to be easily blocked. In this case, it was likely blocked and due to the lack of cover, the pipe was being crushed by the vehicle traffic.

The recommended solutions would be to either reconstruct the driveway with a simple driveway dip enough for water to pass or install a proper culvert under the driveway. Both solutions would remove and not use the small pipe. An alternate that was discussed was to install a 4" or 6" sock pipe from the front ditch at 3813 Cormorant Point Dr. all the way to the inlet at the intersection of Waterwood Dr. and Golf Haven Ter. This would only be recommended if there is a water standing problem along the easterly ditch on Waterwood Dr.

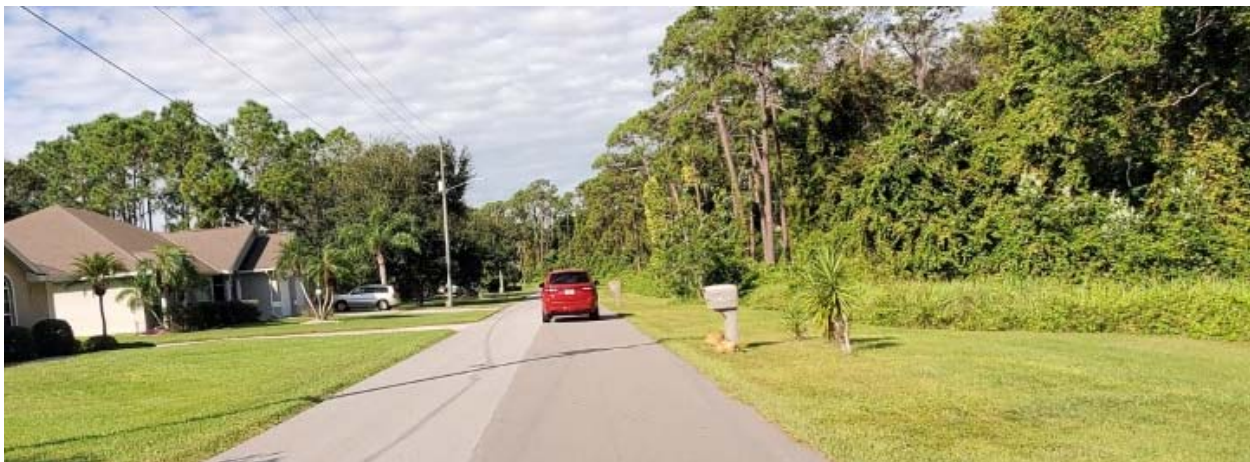
The causes of the drainage issues appear to be related to the driveway construction and condition of the ditches along this segment of road. A good number of driveways appear to have been constructed with no dip in the ditch area or without any culvert to allow water to pass by. The original plans called for ditches on both sides of the road and for the ditch to convey water to the pond to the south west of the road. The condition of the ditch appears to vary along the roadway. In some areas the ditch appears to be in good working order, and others the ditch is silted in or barely present. In some instances, the ditch has landscape and curbing present. This landscape and curbing restrict the flow of storm water in most cases.

Dog Leg Dr. – Very little ditch present on either side of the road.

Solutions for this area may include reshaping the ditch along the easterly and southerly side of the road between the driveways. This would provide an actual conveyance path along the side of the road. The driveways that have not been constructed properly would also need to be reconstructed to provide a dip to allow water to pass without it staging into the road or into the lots to allow it to pass. To correct the drainage in this area it also may require some additional inlets and road crossing culverts be installed to allow water to cross the road. A topographical survey would be recommended before any final determination could be made as to what scope of work would be the most cost effective. An alternate to some of the above recommendations would be to install a run or multiple runs of sock pipe. This could potentially be an alternate to reshaping large portions of the existing driveways. A combination of ditch re-construction and sock pipe would allow the ditch to drain the water more efficiently.

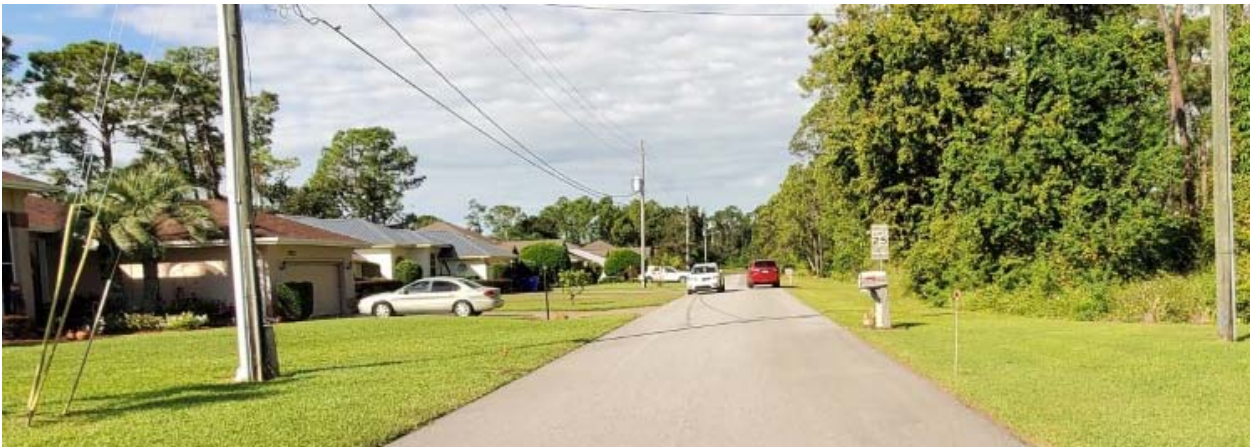
Dog Leg Dr. No apparent Ditch on either Side of the road.

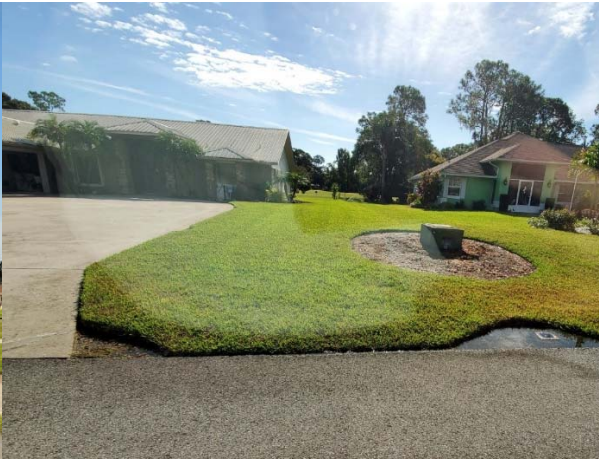
Example of no Ditch or Driveway Dip
