Golf Hammock Owners' Association

Drainage Report

**Lost Ball Drive, Cormorant Point Drive, Dog Leg Drive, Waterwood Drive &
Cormorant Point Drive Intersection Areas**

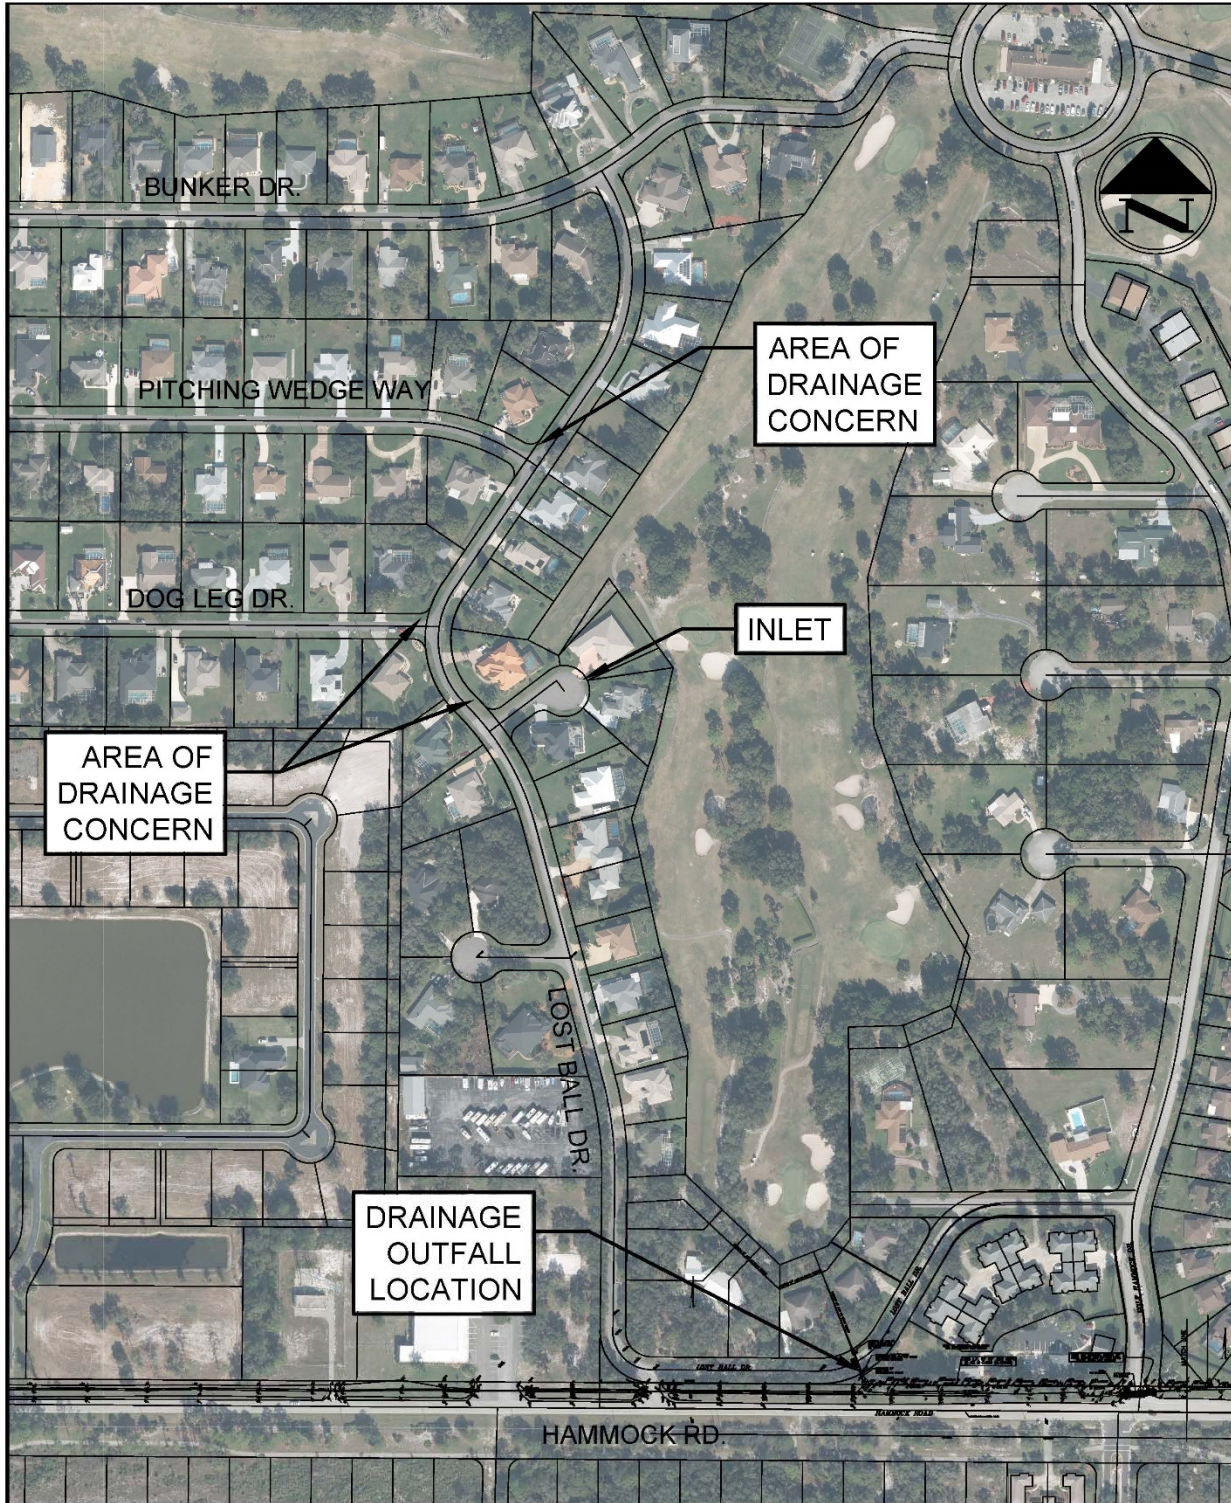
Lost Ball Drive Map:

The issues in the area of Lost Ball Drive were reported as water standing in the road side ditches along a number of homes. The areas pointed out were locations that recently had ditch cleaning. The complaints by residents were mainly that the water was not flowing anywhere and would stand for a day to a week before eventually percolating or evaporating.

Some of the causes of the standing water can be associated with irregular grading of the area, rises and dips holding water. The roads and ditches do not have much slope in the areas of the water standing. It does not take much to cause the water to puddle or get blocked. The driveways are also higher than the ditch bottoms in most cases. This will create a driveway dam or ditch block. This should not be considered a bad thing. It will promote water to percolate back into the ground. In some cases, during a wet rain season, the water table can be elevated causing the water to appear to stay for extended periods of time. Lost Ball also has a number of intersections that do not have any culverts crossing under the road. The original plans intended the water to flow around the corners and to the west down Pitching Wedge and Dog Leg. The inspection during the site visit and looking at some older topo, show the ditches and road slope up for a short length before sloping back down to the west. This explains some of the backup of water on the westerly side of Lost Ball Dr.

Solutions to the standing water in this area may involve additional ditch cleaning as well as the addition of some culvert crossings near the intersections along Lost Ball. The installation of sock pipe may also help to draw down the water in the ditches. This solution would need a good positive outfall location. In this case, the golf course ditch or pipe, if it exists, may need to be improved or cleaned out. Alternate options may include not doing anything. If the water in the ditch percolates or evaporates in 24 to 48 hours, it is normal behavior for this area of Highlands County. The water table can vary from 6+ feet to the surface within Golf Hammock, depending on the soil type (see soil map in the appendix). If the area is experiencing a very wet rainy season, the water table will likely be closer to the surface, which can cause the water in the ditches to stay longer before it percolates. If it is uncommon for the water to stay past 48 hours, it may be safe to postpone any major drainage improvements in the area. It is our recommendation at this time to observe the conveyance systems that take the water away from Lost Ball. This includes the pipe within the golf course and the pipe crossing Lost Ball to the south. It is also recommended to have the existing pipe located so it may be further inspected for condition and blockages and future maintenance. Flow issues can also be determined once this is done. The downstream system will need to be in good working order before any additional flow is tied into it from the upstream side of the drainage system.

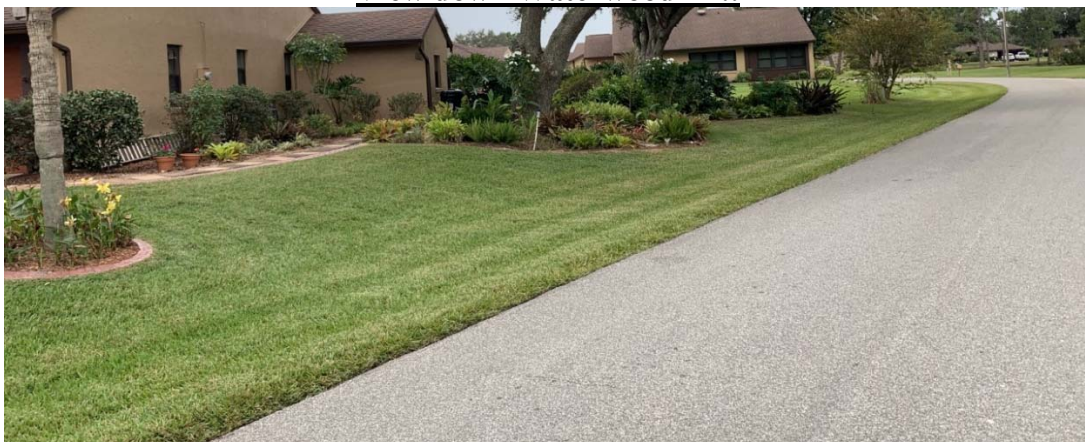
**View down Waterwood Dr.:**

The problem reported for the intersection of Waterwood Dr. and Cormorant Point Dr. was water was standing and getting blocked by the driveway at 3813 Cormorant Point Dr. During the initial inspection, it appeared that the driveway was the culprit in not allowing any flow from the easterly side to cross to the intersection and down Waterwood Dr. After a closer look, it appeared a four-inch pipe was constructed under the paver driveway. This is normally not recommended due to its small size and its ability to be easily blocked. In this case, it was likely blocked and due to the lack of cover, the pipe was being crushed by the vehicle traffic.

The recommended solutions would be to either reconstruct the driveway with a simple driveway dip enough for water to pass or install a proper culvert under the driveway. Both solutions would remove and not use the small pipe. An alternate that was discussed was to install a 4" or 6" sock pipe from the front ditch at 3813 Cormorant Point Dr. all the way to the inlet at the intersection of Waterwood Dr. and Golf Haven Ter. This would only be recommended if there is a water standing problem along the easterly ditch on Waterwood Dr.

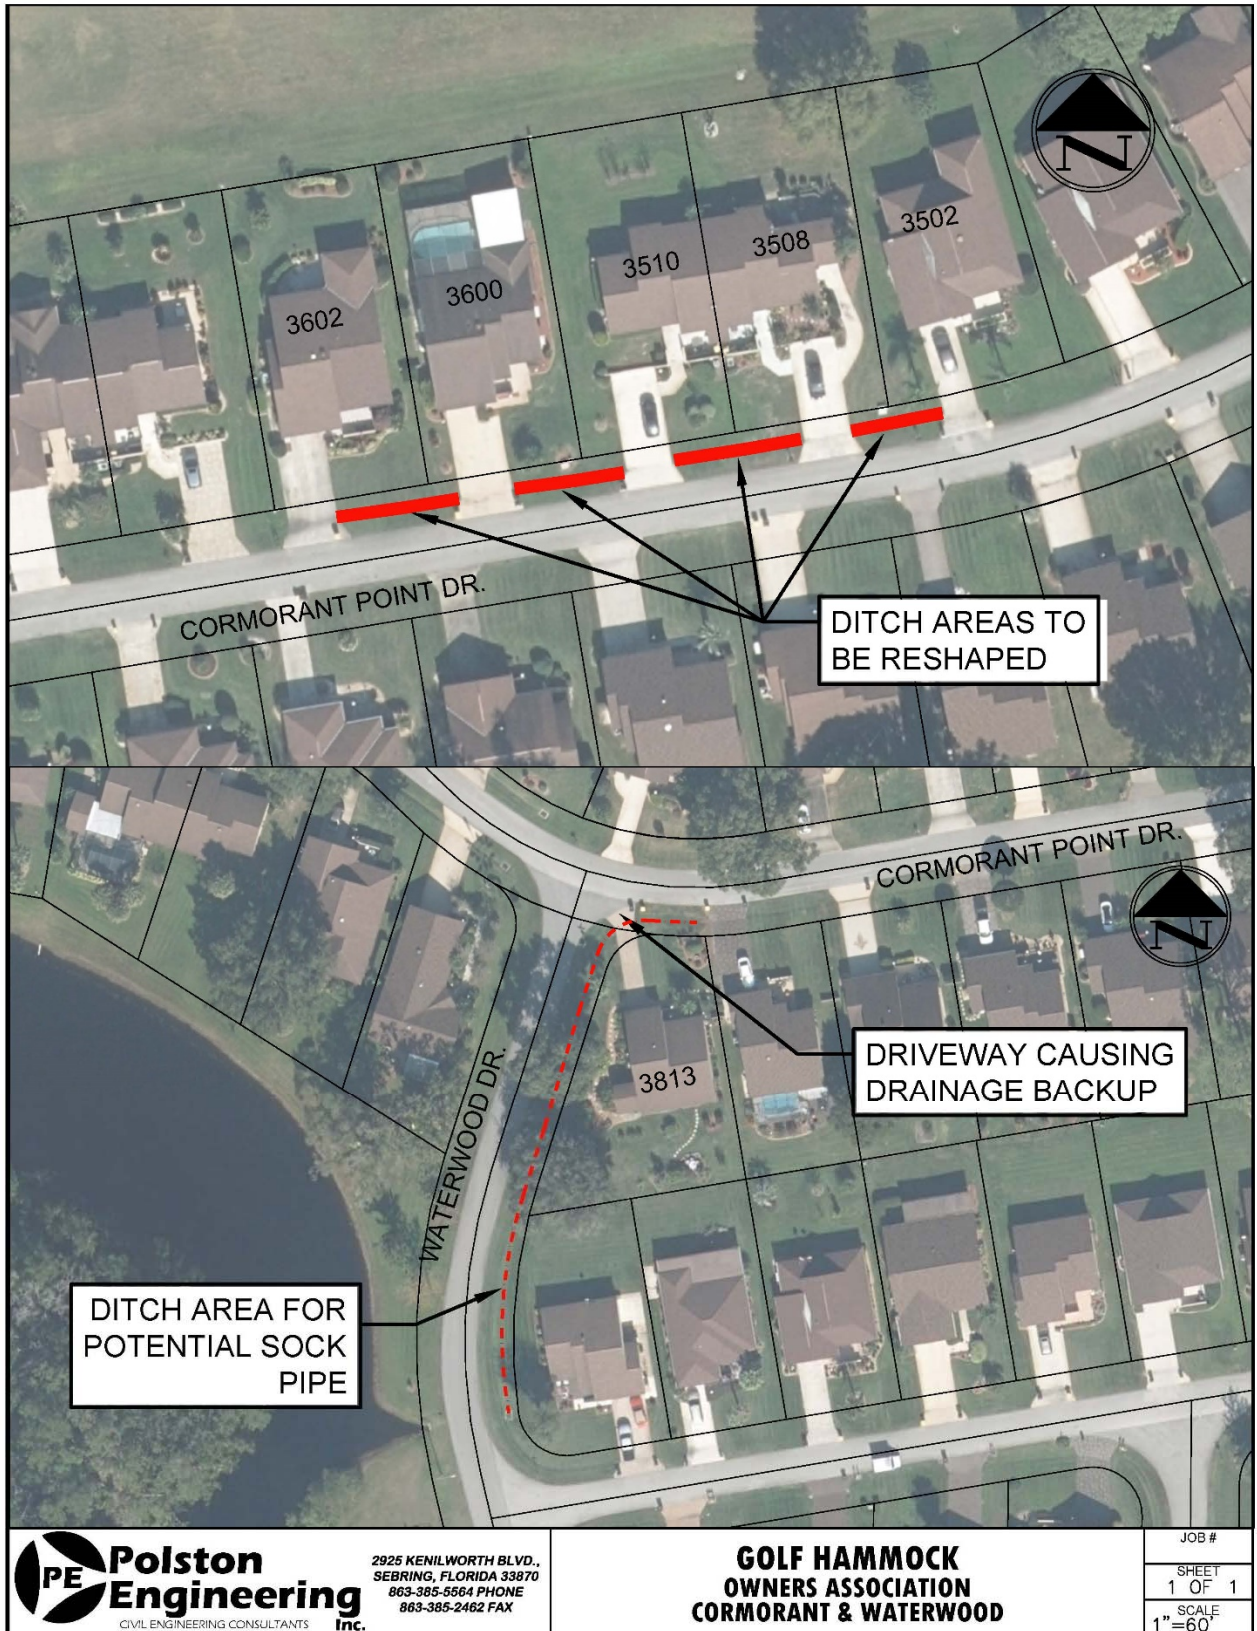
Cormorant Point Dr. & Waterwood Dr. Drainage Areas:

The apparent cause of the water backup is what appears to be fill placed within the right of way ditches between 3502 and 3602.

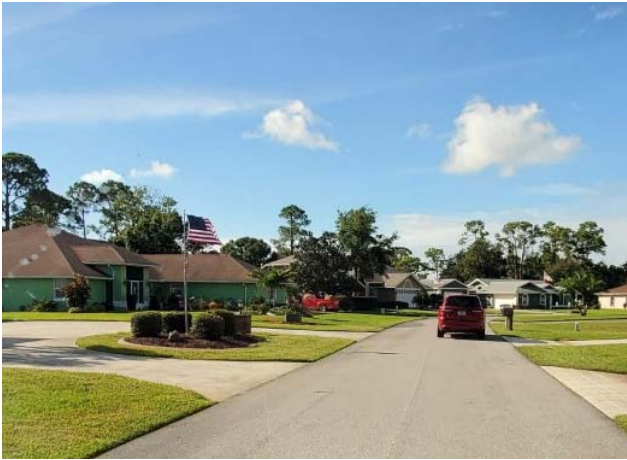
View South along Dog Leg Dr.

Solutions for this area may include reshaping the ditch along the easterly and southerly side of the road between the driveways. This would provide an actual conveyance path along the side of the road. The driveways that have not been constructed properly would also need to be reconstructed to provide a dip to allow water to pass without it staging into the road or into the lots to allow it to pass. To correct the drainage in this area it also may require some additional inlets and road crossing culverts be installed to allow water to cross the road. A topographical survey would be recommended before any final determination could be made as to what scope of work would be the most cost effective. An alternate to some of the above recommendations would be to install a run or multiple runs of sock pipe. This could potentially be an alternate to reshaping large portions of the existing driveways. A combination of ditch re-construction and sock pipe would allow the ditch to drain the water more efficiently.

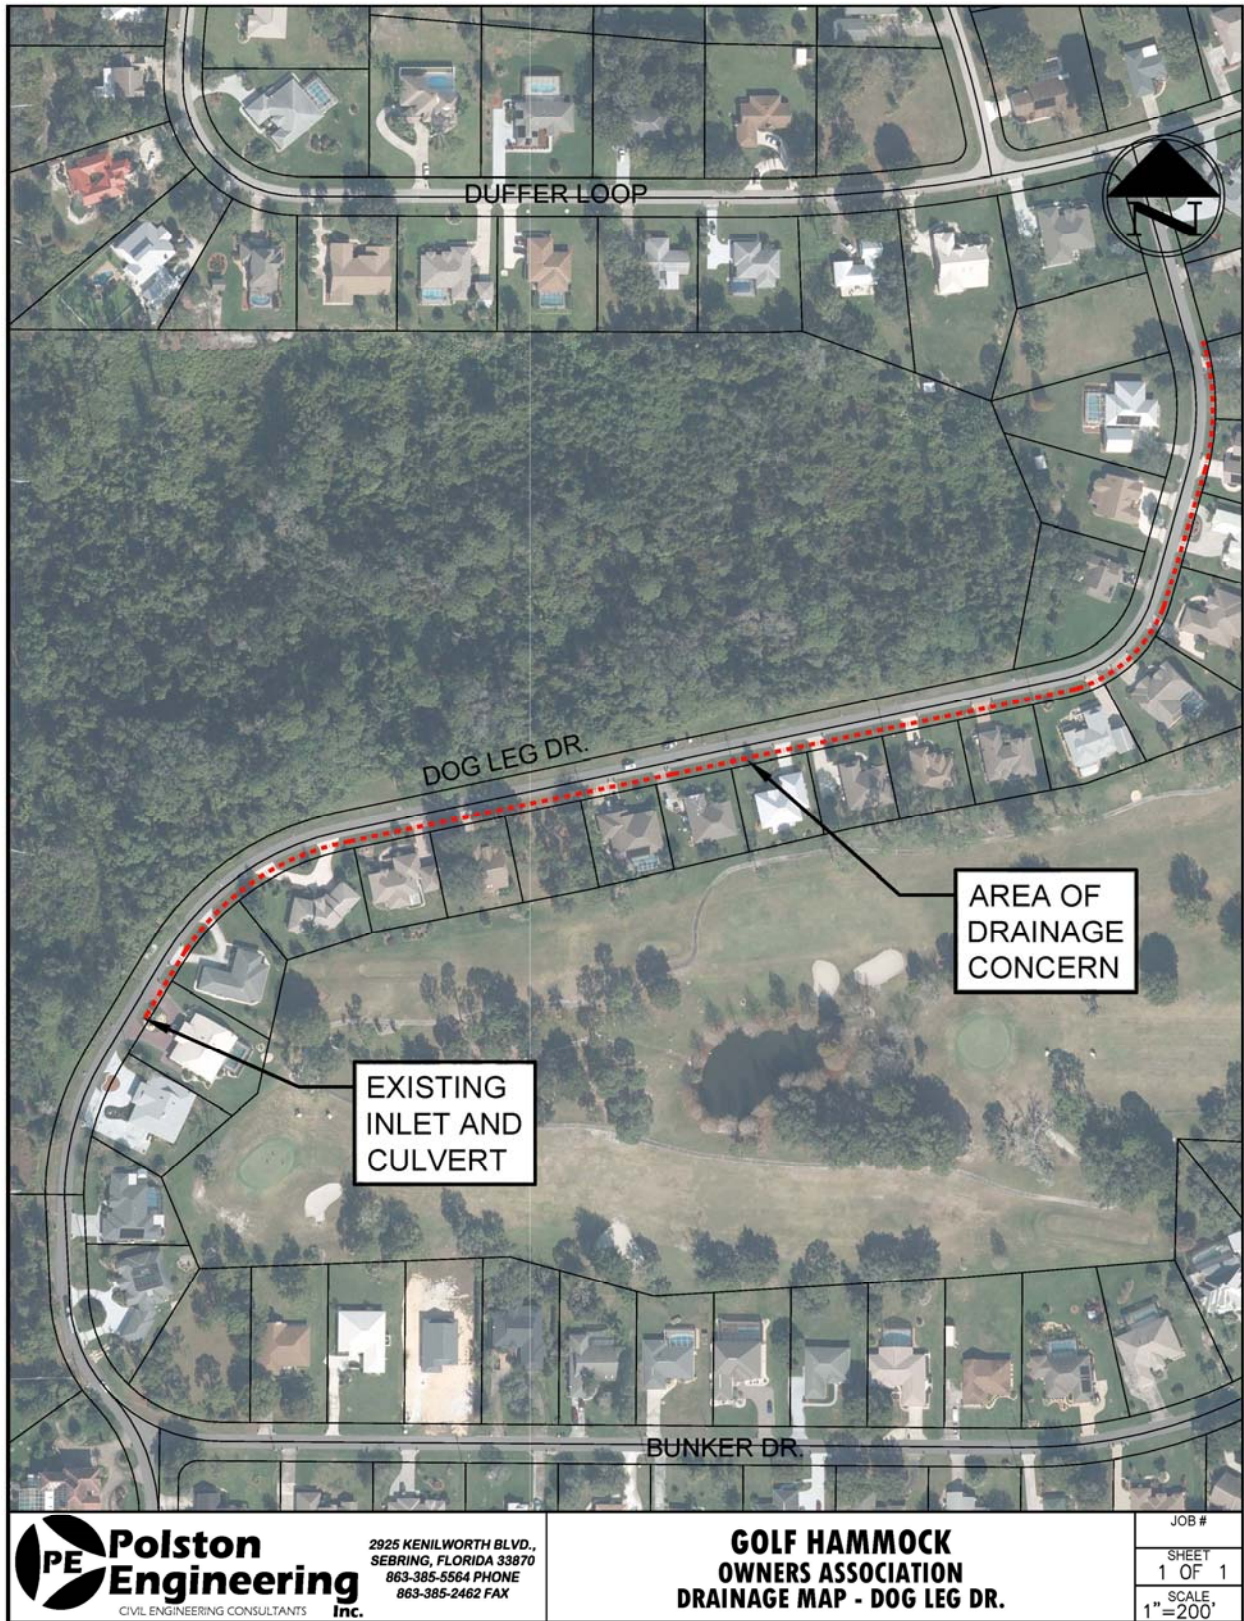
Dog Leg Drive Map:

The drainage issues along the northerly portion of Dog Leg Drive, approximately between 2010 and 2208, have been reported as standing water along large portions of the road side ditch. This area only has homes on the south easterly side of the road. The westerly and northerly side of the road consists mainly of a wetland.

The causes of the drainage issues appear to be related to the driveway construction and condition of the ditches along this segment of road. A good number of driveways appear to have been constructed with no dip in the ditch area or without any culvert to allow water to pass by. The original plans called for ditches on both sides of the road and for the ditch to convey water to the pond to the south west of the road. The condition of the ditch appears to vary along the roadway. In some areas the ditch appears to be in good working order, and others the ditch is silted in or barely present. In some instances, the ditch has landscape and curbing present. This landscape and curbing restrict the flow of storm water in most cases.
